# BELZONA LEAD CHAPEL ROOF

ID: 175

**Application:** RPA-Roof Problem Areas

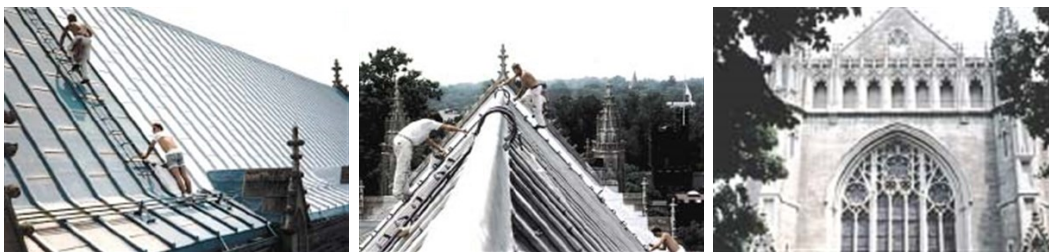
Deteriorating lead roof required long-term protection.

- \* Belzona® 3111 (Flexible Membrane) applied to the right, Belzona® 3921 (GSC Surface Conditioner) being applied at left, uncoated section lower left. ,
- \* Work continues at the apex. ,
- \* Front view of the chapel, lead roof protected. ,

This 70-year-old roof had experienced deterioration over the years due to atmospheric conditions. The university was considering replacement, however, due to the prestigious work that was done on the lead roofs of the House of Lords in the U.K., Belzona was chosen for this project and extended the life of the lead roof.

Application was carried out in accordance with a modified version of Belzona Know-How Leaflet RPA-1.
