BELZONA STAIRWELL MADE SAFE

ID: 176

Customer Location: U.S. Naval Base in South Mississippi,
U.S.A.

Application: FPA-Floor Problem Areas

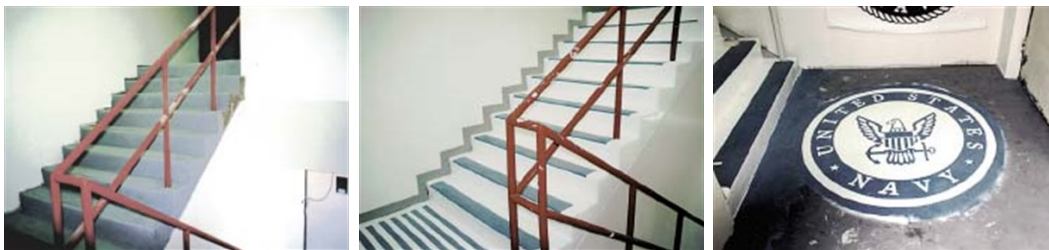
Photograph Descriptions

Stairs were spalled and deteriorated and required a non-slip safety surface.

- * Steps resurfaced with Belzona® 4131 (Magma Screed). ,
- * Belzona® 5111 (Ceramic Cladding) applied for aesthetic reasons, and Belzona® 1341 (Supermetalglide) grip system applied primarily for safety reasons. ,
- * At the foot of the stairs, the non-slip Navy logo was created with a stencil. ,

Application was carried out in accordance with Belzona Know-How Leaflets FPA-1 and FPA-8.

The application of several Belzona products provided a safe and aesthetically pleasing stairwell, suitable for Navy V.I.P.'s.
