# BELZONA SEALANT FOR METHANE POWERED ENGINE PAD

ID: 178

Customer Location: *Wastewater Treatment Plant in Texas, U.S.A.*

Application: *FPA-Floor Problem Areas*

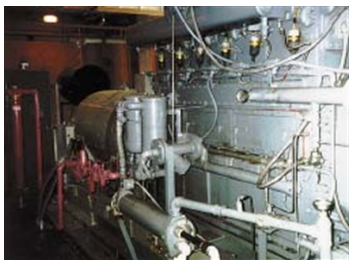
*Old cork expansion joint material hardened, allowing vibration to crack the floor outside of the joint area.*

- \* View of the engines used at wastewater plant. Three engines are located in powerhouse. ,
- \* Old cork removed and new backer rod installed. ,
- \* Finished application, Belzona® 2221 ready to handle vibration. ,
