BELZONA PROTECTS PAPER MACHINE STRUCTURAL STEEL

ID: 181

Application: *TCC-Tanks and Chemical Containment Areas*

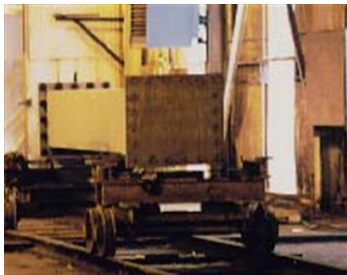
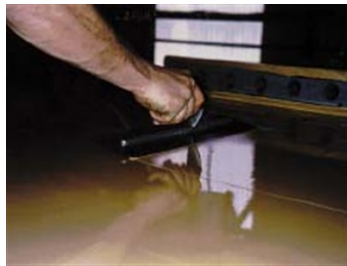
Photograph Descriptions

- * Following surface preparation by grit blasting, columns and beams were moved by rail to an environmentally-controlled application area. ,
- * Belzona® 5811 brushed and eventually troweled to a smooth finish. ,
- * All beams, columns and plates coated with Belzona® 5811. They were then pre-assembled at the fabrication warehouse to check tolerances. ,

The application was carried out in accordance with Belzona Know-How Leaflet TCC-5.

Belzona® 5811 will provide extremely long-term protection of the steel structure. The product is specified for the second phase of a major rebuild. Installation of this new equipment has resulted in the production of their best paper ever.
