BELZONA SLIDES THE CHIPS OFF THE BARK SHAKER

Industry: *Pulp & Paper*

Application: *SHM-Solids Handling Machinery*

Customer Location: *Pulp Mill in Alabama, U.S.A.*

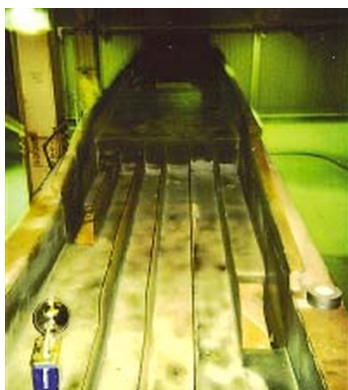
* The bark shaker. ,

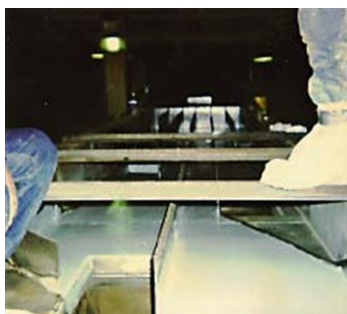
* Belzona® 1341 provides a slick surface and the bark slides off. ,

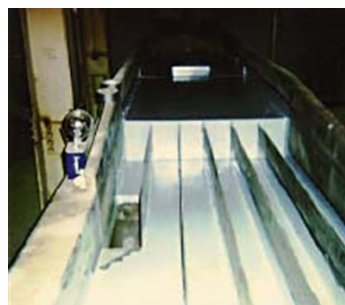
* Another view of the 30 foot long, 8-foot-wide bark shaker coated with two coats of Belzona® 1341. ,
