BELZONA SKYLIGHT WEATHERPROOFING

Customer Location: Luxury Resort on the Atlantic Coast in Northern Florida, U.S.A.

Application: RPA-Roof Problem Areas

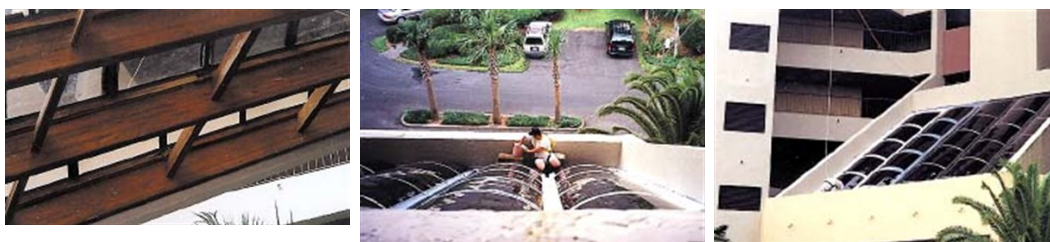
Rainwater leakage through skylight

- * Water leakage was causing problems to the timbers supporting the structure. ,
- * Application in progress. ,
- * The entire 30 x 45 feet of skylight was weatherproofed. ,

Application was carried out in accordance with Belzona Know-How Leaflets RPA-3 and RPA-6.
