# BELZONA HEATING PIPE FITTINGS ABOARD SUPERTANKER

Customer Location: *A 600-foot supertanker barge at Tampa Bay, Florida, U.S.A.*

Application: *VPF-Valves, Pipes and Fittings*

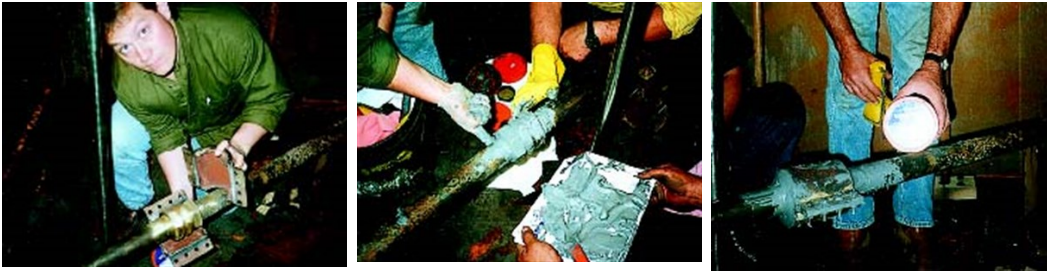
## Photograph Descriptions

*Pipe fittings continued to leak.*

- \* Following surface preparation, a collar was used ,
- \* Application of product ,
- \* Pipe fittings and sea dogs are happy with the repair ,

Application was carried out in accordance with Belzona Know-How Leaflet VPF-11a.
