BELZONA 2141 PROTECTS SHIPS RUDDER AGAINST CAVITATION

ID: 2160

Industry: *Marine*
Application: *SOS-Ships and Offshore Structures*

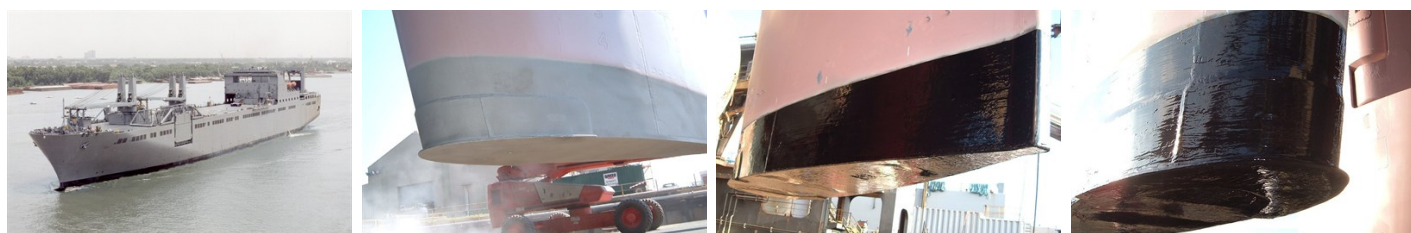
Photograph Descriptions

Cavitation erosion occurring on lower section of the rudder.

- * The ship at sea ,
- * Surface preparation ,
- * After the application of Belzona 2141 ,
- * Another view of the rudder after the application of Belzona 2141 ,

Application was carried out in accordance with Belzona System Leaflet SOS-2.
