# BELZONA 2141 PROTECTS SHIPS RUDDER AGAINST CAVITATION

Industry: Marine  
Application: SOS-Ships and Offshore Structures

Customer Location: Military Sealift Command, USA  
Application Date: 2004

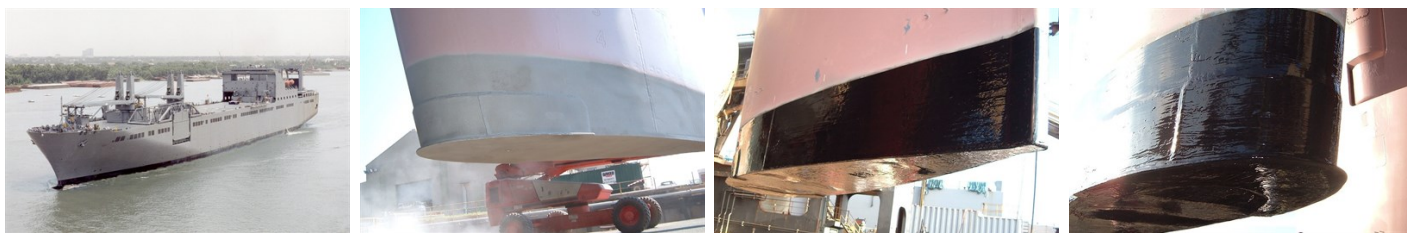
## Photograph Descriptions

*Cavitation erosion occurring on lower section of the rudder.*

- \* The ship at sea ,
- \* Surface preparation ,
- \* After the application of Belzona 2141 ,
- \* Another view of the rudder after the application of Belzona 2141 ,

Application was carried out in accordance with Belzona System Leaflet SOS-2.

The Belzona coating 2141 was successfully tested in the ARL Penn State cavitation channel and is now registered in specifications for rudder protection. Belzona 1341 has been included as the first coat in the latest specifications as it has been shown to enhance the cathodic disbondment resistance of the system.
