BELZONA SUPPORTS ROBOT WELDING TABLE

ID: 2260

Customer Location: Engineering Co, South West Norway
Application Date: October 2010

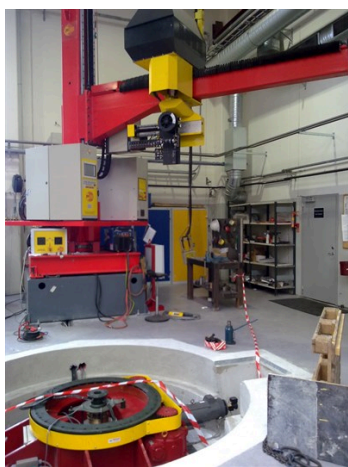
- * Welding table machinery overview ,
- * Void between concrete and steel plate ,
- * Void sealed ,
- * Injection Completed ,

Rotating welding table at workshop fabricating large parts for the Oil and Gas industry.
