# BELZONA LOBE REPAIRS AVOID DELAYS

ID: 2272

Industry: Water / Wastewater  
Application: PDP-Positive Displacement Pumps

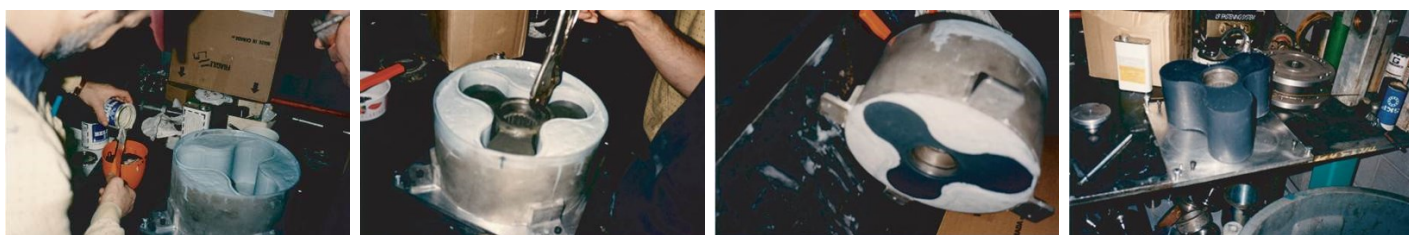
## Photograph Descriptions

*the rubber lobes wear but there is a delay of 4-6 weeks for the delivery of these lobes.*

- \* Preparation of the mould coated with Belzona® 1341 ,
- \* Lobe position in the mould ,
- \* The newly cast lobe in the mould ,
- \* The lobe is ready to be back in service. ,

The application was carried out in accordance with Belzona Know-How System Leaflet PDP-9. A mould, lined with Belzona® 1341 was created from new lobes and used to cast replica lobes using Belzona® 2131 around the steel centres which are grit blasted to achieve maximum adhesion.
