# BELZONA PROTECTS NEWLY CONSTRUCTED BUND

ID: 2367

Newly constructed chemical retention bund

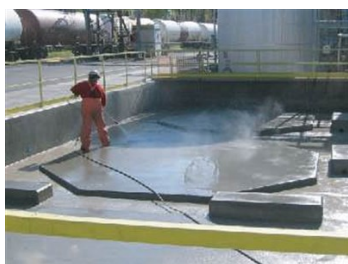
- \* Surface preparation underway ,
- \* Application of the Conditioner ,
- \* Belzona® 4111 fillet applied to floor/wall joints ,
- \* Application of Belzona® 5811. Note use of two colours to assist application ,

The application was carried out in accordance with Belzona Know-How System Leaflet TCC-15. Wall/floor interfaces were reinforced with a fillet of Belzona® 4111 before coating overall with Belzona® 5811.
