# BELZONA PROTECTS RIVER BARRAGE 12 YEARS ON

Customer Location: British Waterways, Teesside, UK

Application Date: Trial September 1997. Full scale application May 1999

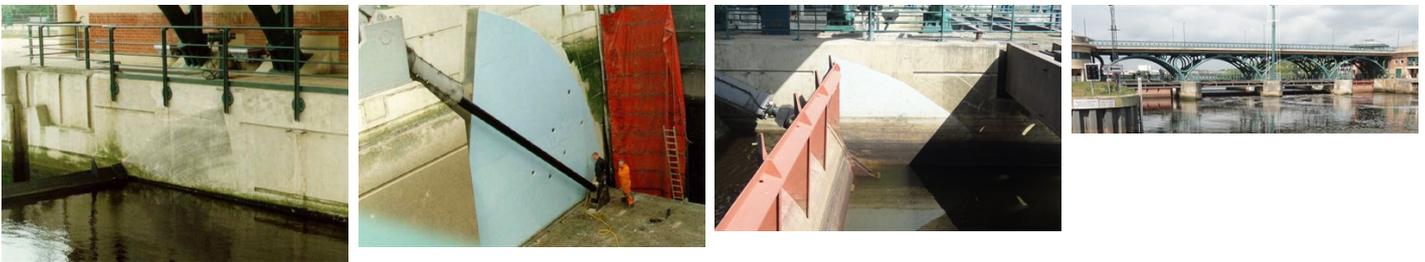
The Tees Barrage was opened in 1995 with a designed life of 120 years. However, the client quickly found the rubber seals on moving gates were being damaged by the concrete walls when the barrage gates were raised and lowered. Trials were conducted for potential solutions in 1997 and only the Belzona application proved itself in practice.

- \* Clear evidence of abrasion on concrete from the rubber seals in 1997 ,
- \* Completed application of Belzona® 1341 in 1999 ,
- \* Still in service over 12 years later in 2011 ,
- \* No breakdown of Belzona® 1341 on any of the 4 barrage gates spanning the Tees in 2011 ,

The full scale application only proceeded once the initial trial had proven successful. A competitor's system had also been tried but wasn't able to be applied successfully. 4 gates each had 2 arcs of Belzona® 1341 applied, totalling about 400m<sup>2</sup>. To date, the

application is over 12 years old and, although each gate undergoes annual inspection, there has been no sign of any breakdown in any of these areas.
