BELZONA STORAGE TANK PATCH REPAIR

ID: 2404

Industry: Oil & Gas
Application: TCC-Tanks and Chemical Containment Areas
Substrate: Carbon Steel
Products: * Belzona® SuperWrap ,

Customer Location: Energy Provider, USA
Application Date: April 2009

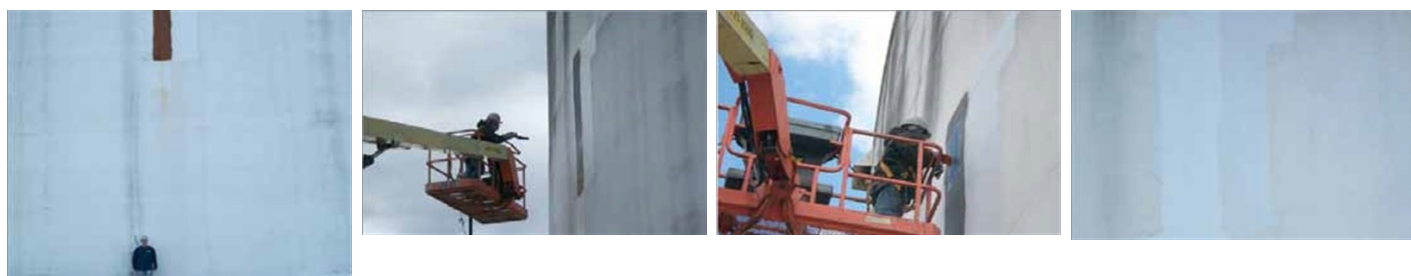
Photograph Descriptions

A vertical weld was found to be porous and product was weeping from a tiny porous spot less than 2mm in diameter. There was no corrosion or thin walling. The defect was located at the 30' level of a 56' high tank. The client needed the tank to be back in service as soon as possible.

- * Defect prior to repair ,
- * Repair area prepared by abrasive blasting ,
- * Application of Belzona® SuperWrap patch ,
- * Belzona® SuperWrap patch inspected and painted ,

Defective vertical seam of a fuel oil storage tank.

The defect was sealed using a Belzona® SuperWrap patch and the repair was continued vertically along the entire length of the weld as a precaution. Belzona's compliant, engineered repair enabled the client to eliminate the need for hot work on the tank, which was a safety concern. This approach also minimized the time the tank was out of service. The tank was repaired, inspected, and ready for service within three days. Furthermore, the tank was back to full height of product three weeks later with successful

results. The Belzona repair is compliant to ISO/TS 24817, DOT Title 49, Chapter 1, Part 192, and ASME PCC-2 Article 4.1 standards and as such provides a permanent, reinforced, composite repair to the tank.
