SMOOTH RUNNING WITH BELZONA

Industry: Water / Wastewater
Application: TCC-Tanks and Chemical Containment Areas
Substrate: Concrete
Products: * Belzona® 4111 (Magma-Quartz) ,
* Belzona® 2131 (D&A Fluid Elastomer) ,

Customer Location: Wastewater treatment plant - Germany
Application Date: October 2000

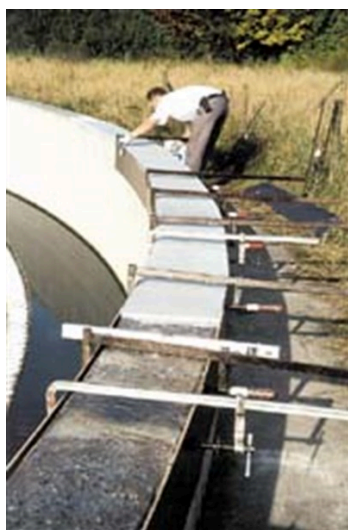
The running track was badly worn by constant abrasion from the distributor wheels.

- * Surface preparation underway ,
- * Metal formers being used to obtain accurate levels ,
- * Completed application with distributor running on track. Note rebuilt and sealed joint. ,

Metal formers were used to accurately reform track surface, with lasers being used to check alignment. Expansion joints were sealed with Belzona® 2131. Application characteristics of Belzona® 4111 allowed accurate rapid rebuild of the track with a hard wearing surface to minimize future maintenance.
