# SMOOTH RUNNING WITH BELZONA

**Industry:** Water / Wastewater  
**Application:** TCC-Tanks and Chemical Containment Areas  
**Substrate:** Concrete  
**Products:** \* Belzona® 4111 (Magma-Quartz) ,  
\* Belzona® 2131 (D&A Fluid Elastomer) ,

**Customer Location:** Wastewater treatment plant - Germany  
**Application Date:** October 2000

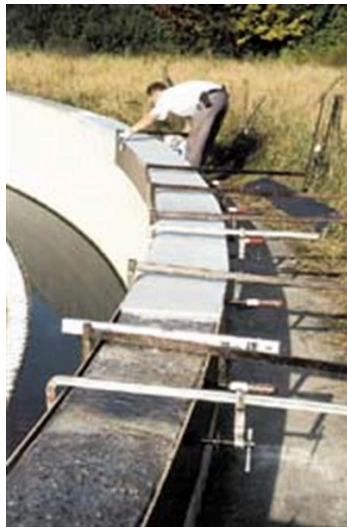
*The running track was badly worn by constant abrasion from the distributor wheels.*

- \* Surface preparation underway ,
- \* Metal formers being used to obtain accurate levels ,
- \* Completed application with distributor running on track. Note rebuilt and sealed joint. ,

Clarifier tank used in treatment of wastewater.

Metal formers were used to accurately reform track surface, with lasers being used to check alignment. Expansion joints were sealed with Belzona® 2131. Application characteristics of Belzona® 4111 allowed accurate rapid rebuild of the track with a hard wearing surface to minimize future maintenance.
