CREATING FLEXIBLE GASKET WITH BELZONA® 2131

ID: 263

Customer Location: *Aluminium producer in Holland*
Application Date: *July 2001*

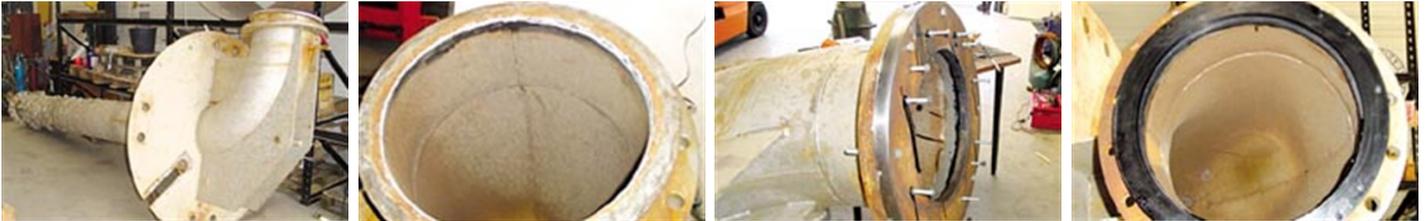
Photograph Descriptions

Electrolytic corrosion on flange face.

- * The pipe section ,
- * The corroded flange face ,
- * Former in place and Belzona® 2131 injected ,
- * The Belzona gasket after removal of the former ,

The application was carried out in accordance with Belzona Know-How System Leaflets GSS-1 and GSS-8.

A steel former was used to obtain correct dimensions and Belzona® 2131 applied using injection techniques. A perfectly fitting 10mm thick gasket was formed that prevents future galvanic corrosion.
