# CREATING FLEXIBLE GASKET WITH BELZONA® 2131

ID: 263

**Customer Location:** *Aluminium producer in Holland*  
**Application Date:** *July 2001*

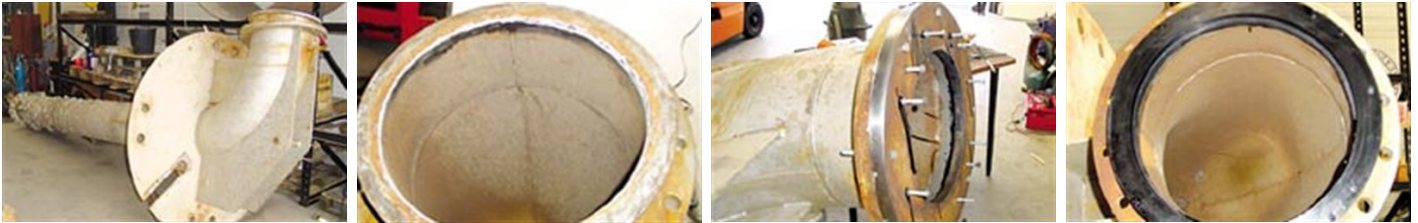
*Electrolytic corrosion on flange face.*

- \* The pipe section ,
- \* The corroded flange face ,
- \* Former in place and Belzona® 2131 injected ,
- \* The Belzona gasket after removal of the former ,

A steel former was used to obtain correct dimensions and Belzona® 2131 applied using injection techniques. A perfectly fitting 10mm thick gasket was formed that prevents future galvanic corrosion.
