# SUCTION ROLL REFURBISHED WITH BELZONA

ID: 265

Industry: *Pulp & Paper*  
Application: *PDP-Positive Displacement Pumps*

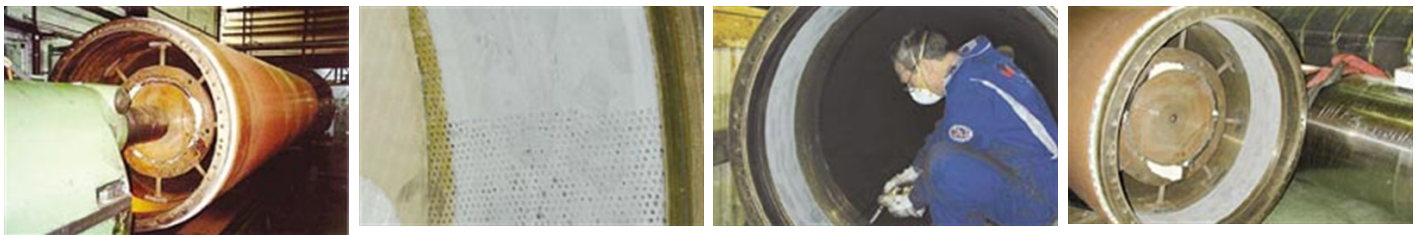
## Photograph Descriptions

*Suction box became loose and scored the suction roll surface.*

- \* The roll mounted in lathe ,
- \* Belzona® 1111 applied and some of the re-drilled holes ,
- \* Final work being done on the rebuilt surface ,
- \* The completed application. ,

The application was carried out in accordance with Belzona Know-How System Leaflet PDP-3. Worn area rebuilt with Belzona® 1111, machined to correct diameter, then holes re-drilled through suction roll.
