# BELZONA PROTECTS AMINE REBOILER

**Industry:** Oil & Gas  
**Application:** TCC-Tanks and Chemical Containment Areas  
**Substrate:** Steel  
**Products:** \* Belzona® 1511 (Super HT Metal) ,  
\* Belzona® 1591 (Ceramic XHT Metal) ,

**Customer Location:** Gas terminal, UK  
**Application Date:** November 2011

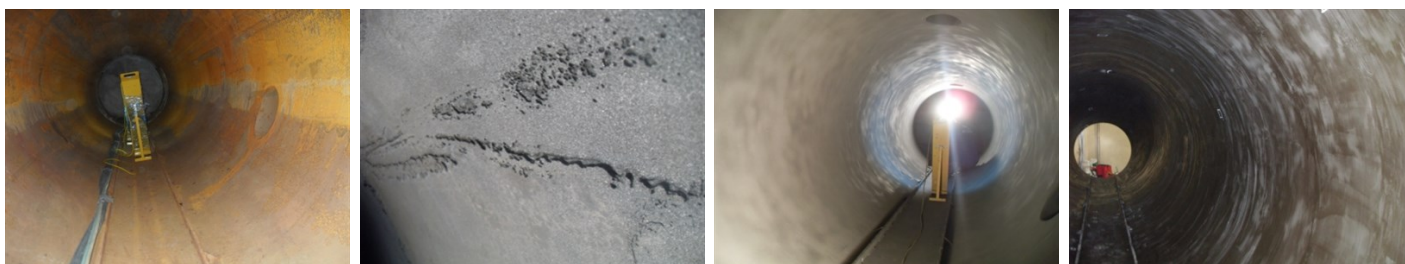
*Internal corrosion with heavy pitting in areas.*

- \* Interior of vessel before blasting ,
- \* Large areas of pitting ,
- \* Vessel before application of first coat Belzona® 1591 ,
- \* Coated vessel before final remedial work carried out ,

Application was carried out in accordance with Belzona Know-How System Leaflet TCC-5. Belzona® 1511 was used to fill in pitting. Belzona 1591 applied for overall corrosion protection.
