# BELZONA PROTECTS LARGE COOLING WATER PUMP

ID: 271

Application: CEP-Centrifugal Pumps

Customer Location: Petrochemical plant in Saudi Arabia.

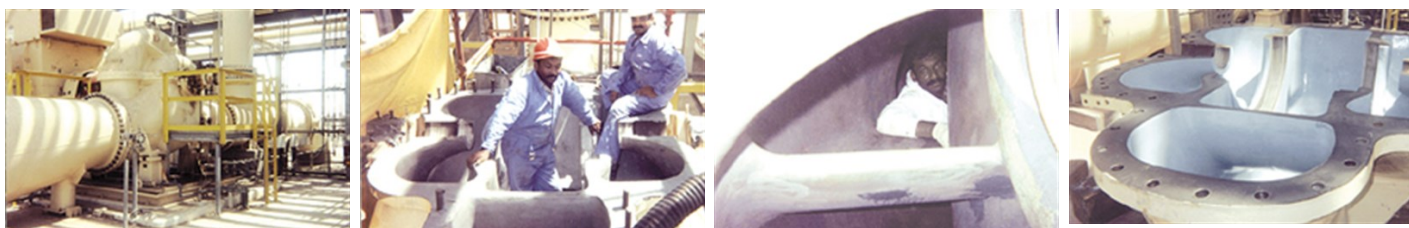
## Photograph Descriptions

*Cavitation and general erosion-corrosion damage had reduced the pumps efficiency to unacceptable levels. The plant has a limited power supply and was looking for all ways to reduce demand.*

- \* General view of the pump installation ,
- \* The size of pump is clearly evident ,
- \* Rebuilding work underway ,
- \* Completed application ,

1.5 meter diameter suction split casing pump handling a 20 meter head of sea water.

The application was carried out in accordance with Belzona Know-How System Leaflets CEP-2, CEP-3, CEP-5, and CEP-10.

Belzona® 1341 not only restored the original efficiency, but provided reduced power demand. This was more important to the plant than cost because of the lack of power available.
