# BELZONA PROTECTS FLARE DRUM

ID: 2740

Flare knock-out drum

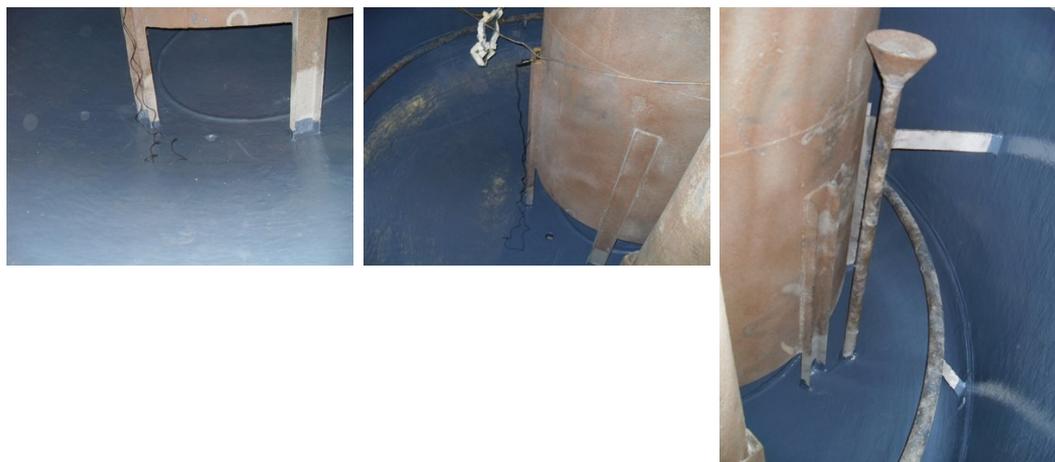
*Vessel suffering internal corrosion. Coating required to extend service life of the vessel.*

\* 1, 2 & 3. various views of the Belzona® 1391 applied to the vessel interior. ,

Application was carried out in accordance with Belzona Know-How System Leaflet TCC-5.

Belzona® 1391 provides excellent corrosion protection at elevated temperatures. In particular the coating is capable of withstanding the extreme variations in temperature and pressure the vessel is exposed to. The ambient temperature curing coating lends itself to application on-site.
