# BELZONA RESTORES LOCAL BANK

ID: 2776

Application: WPA-Wall Problem Areas

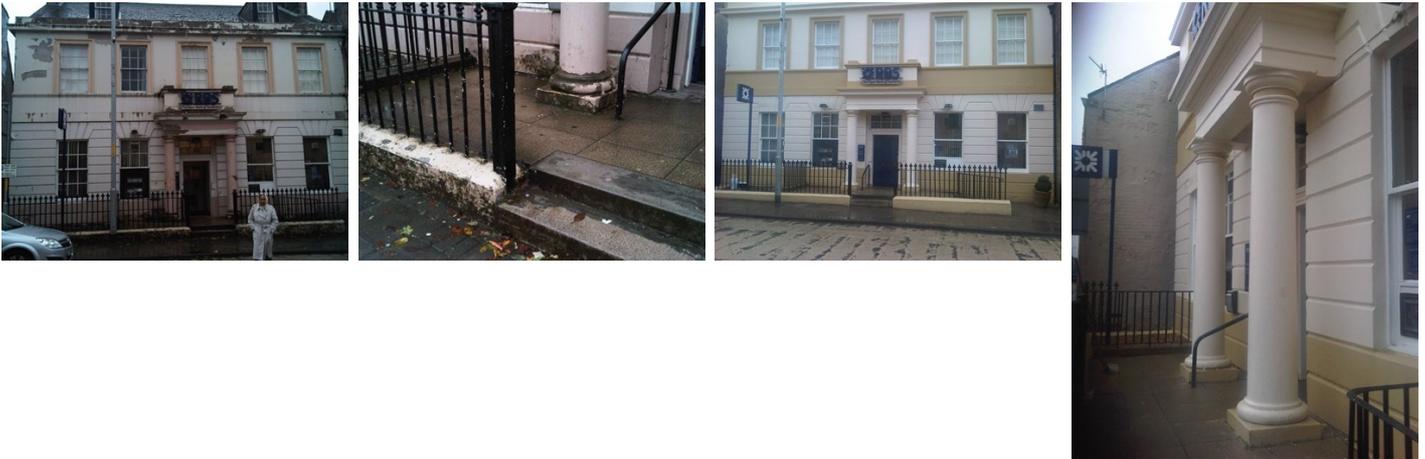
Age and the effect of weather had caused serious deterioration to the buildings facade.

- \* Fascia of the building prior to application ,
- \* Damaged Column ,
- \* General view of the completed application ,
- \* The refurbished bank entrance ,

Application was carried out in accordance with Belzona Know-How System Leaflets WPA-1 and WPA-4. The defective external wall coatings were removed. Some of the broken profiles around the windows and the lintel above the front door were repaired with Belzona® 4141. Belzona® 5151 was then applied to the stonework to protect the surface from further damage.
