BELZONA REDUCES FUEL CONSUMPTION OF A HIGH SPEED PASSENGER FERRY

ID: 278

Industry: *Marine*
Application: *SOS-Ships and Offshore Structures*

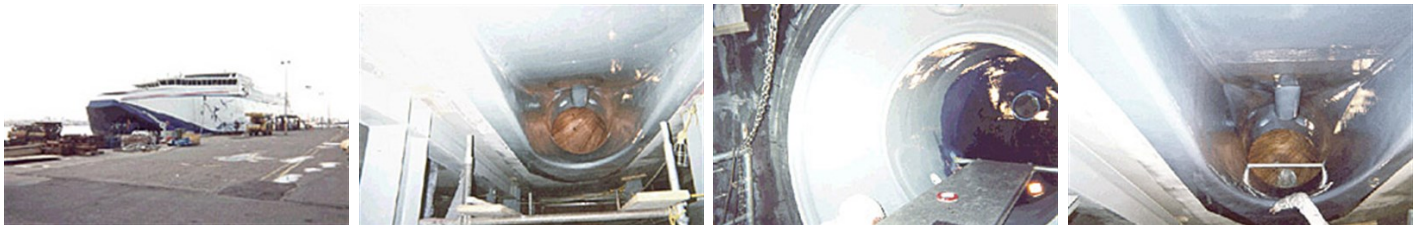
Photograph Descriptions

Original specified coating material actually decreased the efficiency of the jets. Increase in jet drive efficiency sought to reduce fuel consumption and increase speed.

- * An overview of the passenger ferry ,
- * View of jet inlet (1st coat of Belzona® 1341) ,
- * View of outlet coating complete ,
- * View of inlet (2nd coat of Belzona® 1341) ,

Jet drive coating on high speed passenger ferry.

The application was carried out in accordance with Belzona Know-How System Leaflet SOS-2.

Belzona has an approval by KaMeWa North America as well as an ABS approved procedure for Jet drive coating. An overall increase in speed was achieved as a result of the Belzona coating.
