# BELZONA PRESCRIBED AT UNIVERSITY HOSPITAL

ID: 293

Customer Location: University Medical Center  
Application Date: 1986

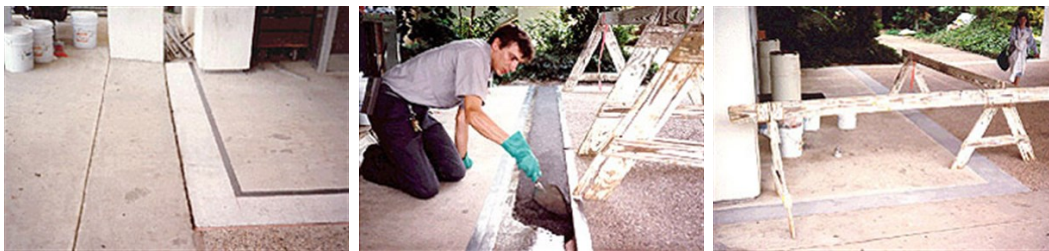
*The entrance to the medical center was irregular from the concrete slabs settling "this is a high traffic area, with new born infant incubators, patients in wheel chairs, and sensitive instrumentation all having trouble crossing the area.*

- \* 1-inch transition between slabs ,
- \* Troweling in the Belzona® 4111 ,
- \* Finished application in front of the hospital ,

The application was carried out in accordance with Belzona Know-How System Leaflet FPA-1. Belzona® 4111 (Magma Quartz) was used to level the transition area between slabs, giving a smooth transition.

Because Belzona can be feather edged and has superior adhesion to the existing concrete, heavy traffic will not deteriorate the cold joint between slabs.
