BELZONA REFURBISHES SCHOOL ROOF

ID: 2971

Hall/Classroom roof on School

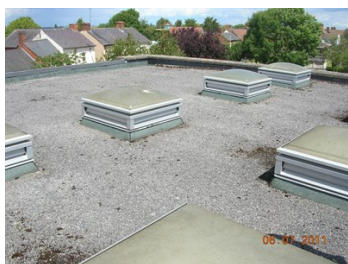
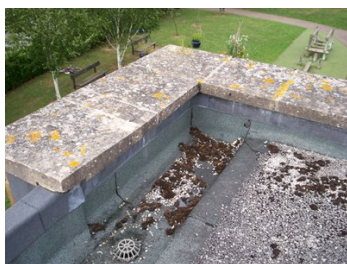
Due to age and cracks in both the parapit walls and in the ashfelt the roof was leaking into the classrooms below.

- * 1. and 2. Before Application ,
- * 3. and 4. After Application ,

Application was carried out in accordance with Belzona System Leaflet RPA-6 and RPA-10
