BELZONA SURFACED TRACK OF SETTLEMENT BASIN PASSES THE TEST

Industry: Water / Wastewater

Application: FPA-Floor Problem Areas

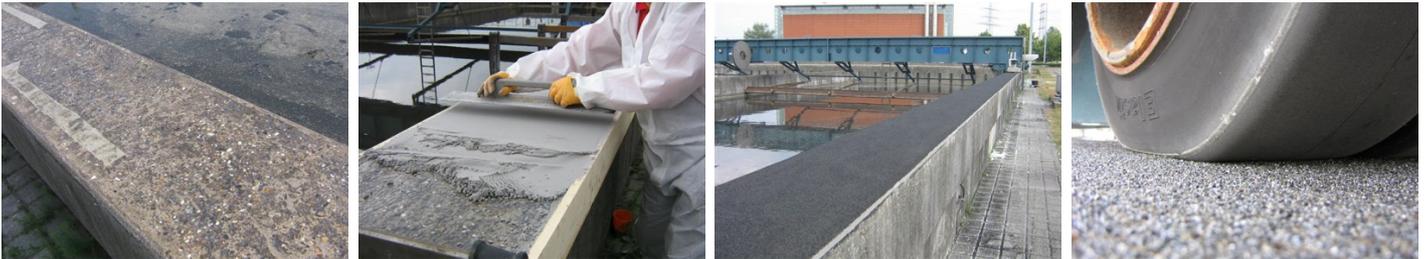
Photograph Descriptions

Scraper wheels and weather had caused wear to the concrete.

- * Condition of the tracks before repair ,
- * Application of Belzona® 4111 using a float ,
- * Completed application ,
- * Track still in excellent condition after one year ,

Application was carried out in accordance with Belzona Know-How System Leaflets FPA-1 & 8. After preparing the top of the walls with a milling machine, the substrate was rebuilt and levelled with Belzona® 4111. The thickness varied between 2 and 50 mm. To provide additional traction for the wheels, Belzona® 5811 was applied and Belzona® 9211 added to the surface to provide a positive grip system.

The customer had previously tried to patch repair the track using steel fibre reinforced concrete, which, however, delaminated quickly. Subsequent repairs with other construction products equally failed. Even after the very hard winter of 2010/2011, the Belzona system is still in excellent condition thanks to its ability to withstand frost and subzero service conditions. The satisfied
