BELZONA REDUCES SLIP RISK ON SCHOOL STEEL WALKWAY

ID: 3027

Customer Location: School, Derbyshire, UK
Application Date: April 2010

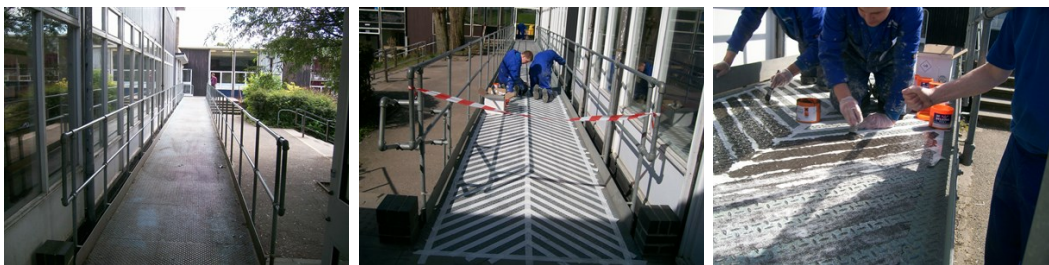
Photograph Descriptions

The chequer plate had become polished over time by regular foot traffic by the pupils and staff and was posing a significant slip risk to all who used it. The walkway was also used by wheelchair bound pupils and a positive grip was essential for their safe passage.

- * Situation prior to application ,
- * Preparation in progress, marking out of application area ,
- * Belzona® 1821 being applied directly followed by Belzona® 9221 surefoot aggregate ,
- * Completed grip system ,

The application was carried out in accordance with Belzona Know-How System Leaflet FPA-8. Chevrons were created and approximately 50% of the total surface area was covered with the grip system.

The walkway area was prepared and the system applied over 5 days. The client was delighted with the result knowing that the walkway could be used safely by all. Alternative systems involving adhesive tape or mechanically attached surfaces which can loosen over time are not effective on chequer plate and can create additional trip hazards. Belzona® 1821 Fluid Metal creates a strong bond with the substrate and aggregate providing a high performance and long life positive grip system.
