BELZONA SEALS TRANSFORMER LID FLANGE

Customer Location: Gas Distributor, UK
Application Date: 2011

Lid gasket flange on this 66-11Kv transformer.

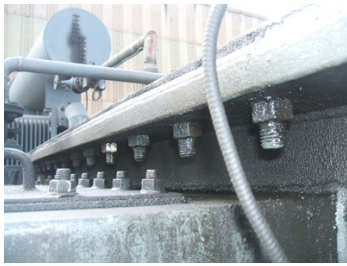
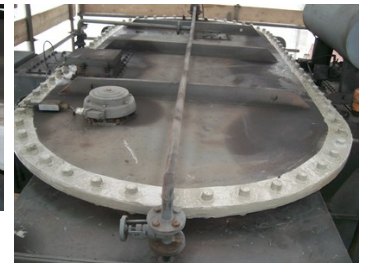
Most of the gasket had failed around the 10m perimeter of the lid, with oil seeping down the sides and going to ground. Unfortunately it was not possible to drain the oil below the gasket level and so the application had to be pursued as a live leak with a 1m head pressure.

- * Original condition of flange with header tank at rear ,
- * Encapsulation of bolts with Belzona® 1161 ,
- * Completed repair close up ,
- * Finished work after 3 days ,

Application was carried out using Belzona Know-How System Leaflet VPF-11 as a guide. Area of flange and bolts were pressure cleaned and grit blasted. Live leaks stemmed with Belzona® 1291 and Belzona® 1221. Bolt heads top and bottom were encapsulated with Belzona® 1161. Belzona® 1161 and Belzona® 9341 used to create a reinforced band around the flange. Finally over coated with Belzona® 5831.
