THERMAL EXPANSION/CONTRACTION IS NO MATCH FOR BELZONA

ID: 325

Application: *VPF-Valves, Pipes and Fittings*

Steel wastewater process pipe through concrete floor.

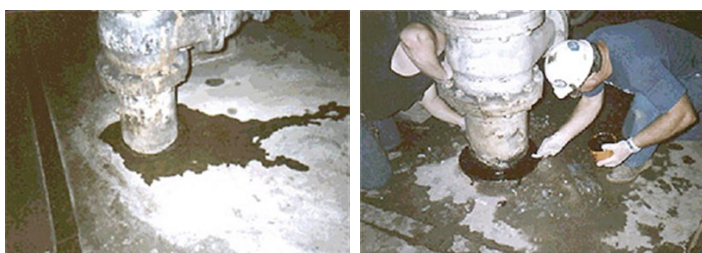
Photograph Descriptions

The concrete has a different coefficient of thermal expansion/contraction than the metal pipe. The result of this difference, is the erosion of the metal pipe at the interface, and subsequent leaks.

- * View of pipe leaking at the floor penetration ,
- * Repair completed with Belzona® 4211 (Magma Stop) and Belzona® 2131 (D&A Fluid Elastomer) ,

Belzona® 4211 (Magma Stop) was used to stop the active leak, without interrupting the process flow. Once the leak had been stopped, Belzona® 2131 (D&A Fluid Elastomer) was used to encapsulate the repair perimeter and absorb the movement of the two substrates. It is a good idea to rough cut around the perimeter of the Belzona repair and pour the elastomer in this joint to allow for movement.
