DISCHARGE PIPES PROTECTED WITH BELZONA

ID: 3333

Customer Location: Phosphate plant, Mohammedia,
Morocco

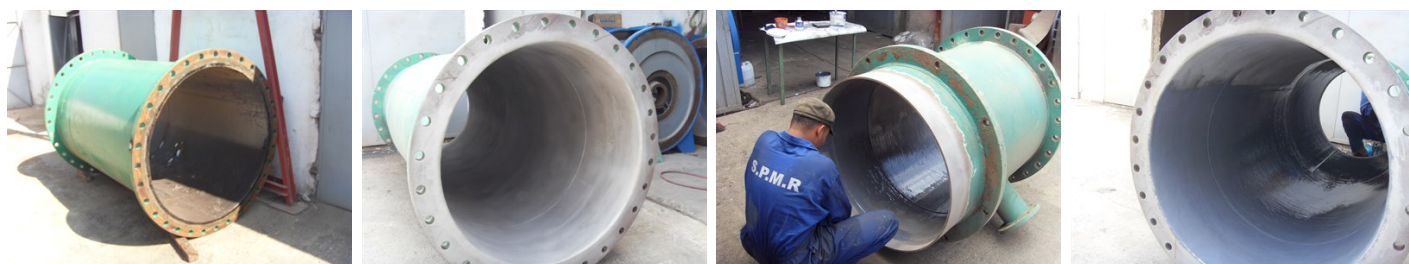
Photograph Descriptions

The discharge pipes were new, but required an erosion corrosion resistant lining to protect from the acidic slurry.

- * Original pipe ,
- * Gritblasted discharge pipe ,
- * Application in progress ,
- * Completed application ,

The application was carried out in accordance with Belzona Know-How System Leaflet VPF-2.

The excellent erosion resistance of Belzona® 1321 combined with its chemical resistance will extend the lifespan of these pipes.
