BELZONA STOPS ACTIVE JET FUEL LEAK

ID: 334

Customer Location: Wastewater treatment facility in South Florida, USA

Application: VPF-Valves, Pipes and Fittings

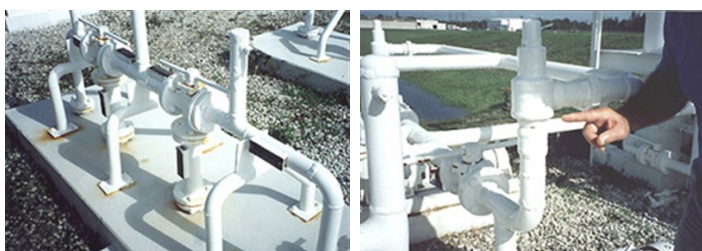
Photograph Descriptions

The wastewater treatment facility utilizes jet engines for standby power generation. Jet fuel is stored on the premises. Distribution system for JP4 jet fuel consisting of multiple valves, pipes and fittings was not containing 100% of the fuel.

- * Several porous welds and threaded fittings of jet fuel distribution system sealed. ,
- * Close up view of threaded fittings. Jet fuel leak stopped. ,

Active JP4 jet fuel leaks through porous welds and active fittings.

The application was carried out in accordance with Belzona Know-How System Leaflet VPF-11a.

The Belzona products demonstrate excellent chemical resistance to JP4 jet fuel. The repair is still providing leak free service even after years of operation.
