BELZONA COATS PUMP BOWLS

ID: 34

Customer Location: Power Plant in Mississippi
Application Date: October 1995

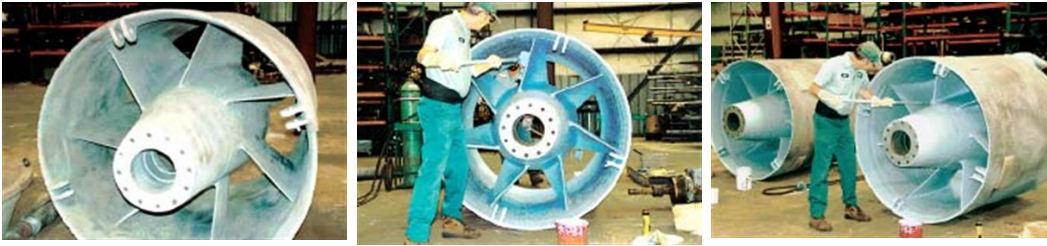
Photograph Descriptions

Corrosion damage to the housing; power plant wanted to increase the efficiency of the pump.

- * The impeller ,
- * Application of Belzona® 1341 in progress ,
- * Two pump bowls coated ,

Two main cooling water pump bowls

The application was carried out in accordance with Belzona Know-How Leaflets CEP-3 and CEP-10.

Belzona® 1341 (Supermetalgilde) was chosen for its efficiency enhancement properties in fluid flow systems.
