BELZONA PROTECTS NEWLY CONSTRUCTED PLANT ROOM

ID: 3419

Customer Location: University, Wolverhampton, UK
Application Date: May 2012

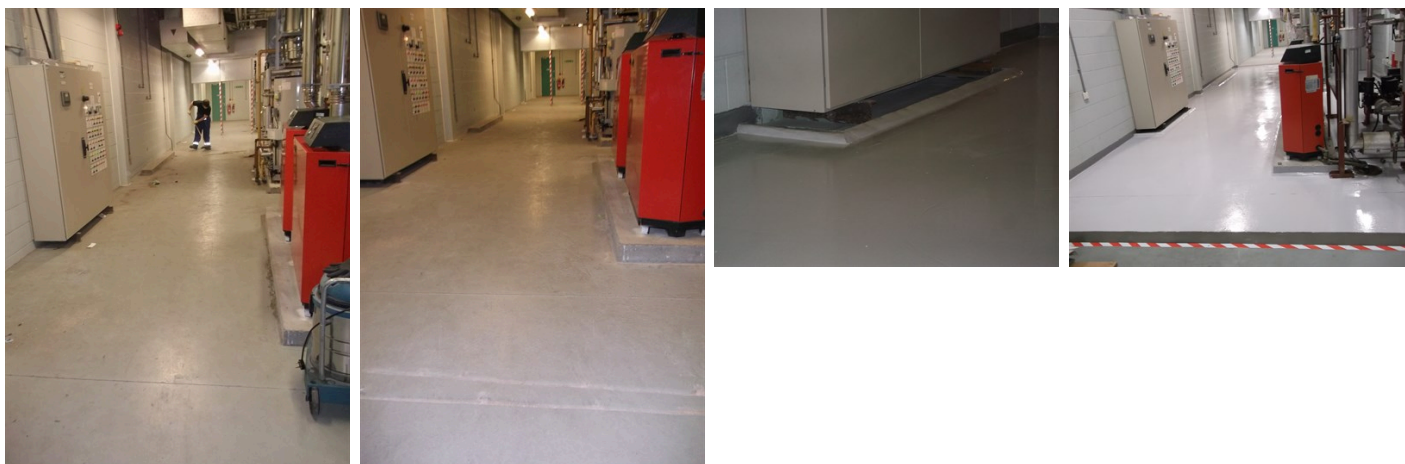
Photograph Descriptions

- * Clearing of plant room floor ,
- * Floor abraded in preparation for Belzona® 4131 bund and fillets ,
- * Section of bunded area ,
- * Completed plant room floor bund after coating with Belzona® 5231 ,

Application was carried out in accordance with Belzona System Leaflets FPA-3 and TCC-15. Belzona® 4131 was used to create raised bunded areas and covings before applying Belzona® 5231 to completely seal the floor area.

The customer had already experienced floods in other unprotected plant rooms and knew Belzona would be able to create the necessary protection required. The Belzona® 4131 enabled the construction of a raised containment area for spills for sealing with the impermeable Belzona® 5231. This coating has the added benefit of containing a non-slip aggregate improving the safety of the plant room when floor is wet.
