PROTECTION OF DISTRICT HEATING SYSTEM

ID: 3430

Customer Location: Electricity utility, Sweden
Application Date: September 2009

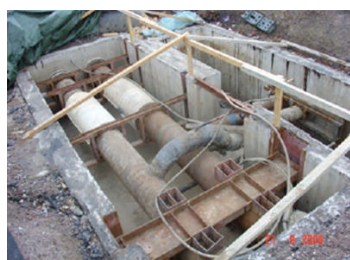
Corrosion on feed and return pipes as well as on supporting steelwork. System is in continuous use so products capable of application to hot surfaces required.

- * District heating Chamber before renovation ,
- * Dry ice blasting ,
- * Coating being applied ,
- * The finished application ,
