# BELZONA SEALS CARBON STEEL DIGESTER DOME

ID: 348

Customer Location: Wastewater treatment plant, primary digester

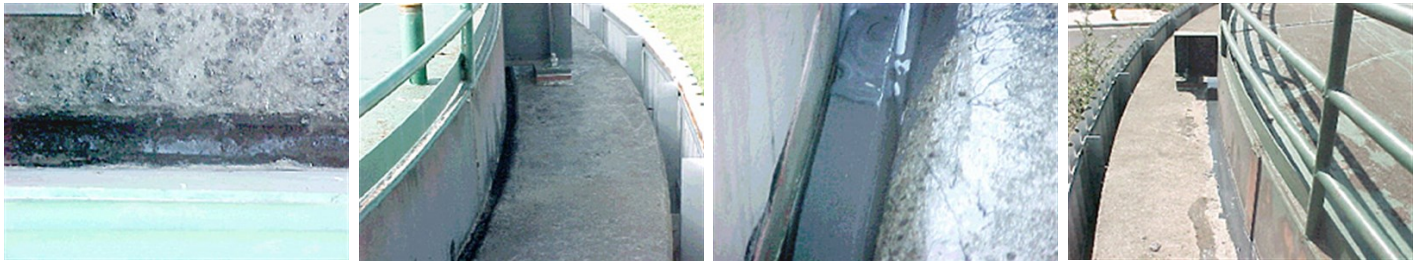
## Photograph Descriptions

This 80 foot diameter carbon steel digester dome was originally sealed with a tar pitch. The seal had broken down over the years and was leaking at several locations.

- \* Three inches of original job excavated ,
- \* Dome seal grit blasted and blown dry ,
- \* Pouring of Belzona® 2221 (MP fluid Elastomer) ,
- \* 225 linear feet completed ,

There have been no leaks since the completion of the job and Belzona was the only proposal that assured the longevity of the repair.
