BELZONA SEALS CARBON STEEL DIGESTER DOME

ID: 348

Customer Location: Wastewater treatment plant, primary digester

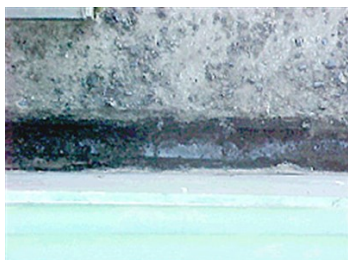
- * Three inches of original job excavated ,
- * Dome seal grit blasted and blown dry ,
- * Pouring of Belzona ® 2221 (MP fluid Elastomer) ,
- * 225 linear feet completed ,
