BELZONA STABILIZES GAS PIPELINE ON BRIDGES

ID: 3541

Customer Location: Gas transmission company, Slovakia
Application Date: First repair in 1998

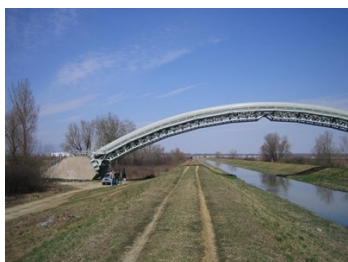
* General view of pipe bridge Preparing/measuring location for supports Belzona® 1111 used to bond wear pad Completed sliding support in place. ,

Pipe bridges supporting gas pipeline over waterways.

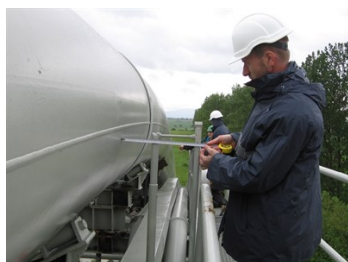
Customer needed to keep pipe line in fixed position. To achieve this several sliding supports between bridge and pipe had to be installed. Welding was not possible as gas line was active. Each bridge has 16 such supports.
