BELZONA TANK FARM

ID: 36

Customer Location: Chemical Plant in South Alabama, USA
Application Date: August 1995

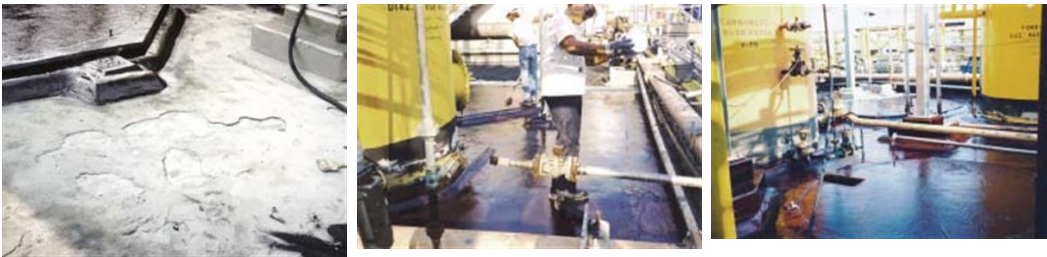
Photograph Descriptions

Harsh chemicals attacking existing substrate which was installed in 1993.

- * View of damage to polymeric repair compound ,
- * Application of Belzona® 4311 (Magma CR-1) in progress ,
- * 5000 sq. ft. area protected ,

The previous polymeric concrete repair material was damaged by chemical attack. The concrete was repaired and all areas protected.

The application was carried out in accordance with Belzona Know-How Leaflets TCC-9 and TCC-15.
