BELZONA LEADING EDGE SOLUTION FOR WICKET GATES

ID: 3618

Customer Location: Turbine manufacturer, France.
Application Date: June 2009

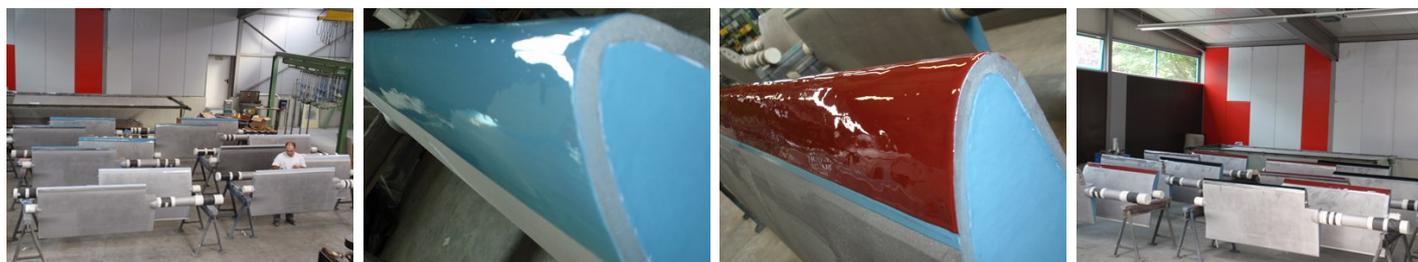
Photograph Descriptions

Due to the operating environment, wicket gates suffer from corrosion and abrasion on the leading edge, due to entrained solid particles in the water.

- * View of the wicket gates after blasting ,
- * Belzona® 1341 applied to offer erosion corrosion protection ,
- * Belzona® 2121 applied to offer impact resistance ,
- * View of the wicket gates completed ,

Application was carried out in accordance with Belzona Know-How System Leaflet CEP-3. Belzona® 1341 was applied to offer resistance to erosion corrosion. As the leading edges are known to suffer from impact damage due to solids in the water, Belzona® 2121 was applied in two coats (red and black) to offer impact protection in these specific areas.
