BELZONA SECURES "A" BRACKETS TO YACHT HULL

ID: 368

Industry: Marine
Application: SOS-Ships and Offshore Structures

Customer Location: Luxury Yacht Builder in UK
Application Date: September 2000

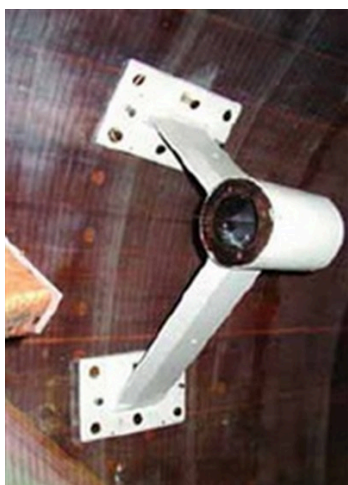
Photograph Descriptions

Irregular shim required to ensure long term, stress-free attachment to curved GRP clad surface. Underlying hull is timber and steel.

- * Bracket positioned using aligning wire and jacking bolts ,
- * Belzona® 1121 being injected between hull and bracket ,
- * Completed application ,

Application was carried out in accordance with Belzona Know-How System Leaflet GSS-9.

The Belzona provides a high-strength irregular shim under "A" brackets ensuring no stress points on the hull. Non-slump properties

of the Belzona important as gaps to be filled ranged from 3 to 25mm (1/8" to 1")
