# BELZONA RESTORES AND PROTECTS HISTORIC BATTLESHIP, NOW A FLOATING MUSEUM

Customer Location: *U.S. Coast Guard/Baltimore Maritime Museum - Baltimore, Maryland U.S.A.*

327-Foot High Endurance Cutter - USCG Taney

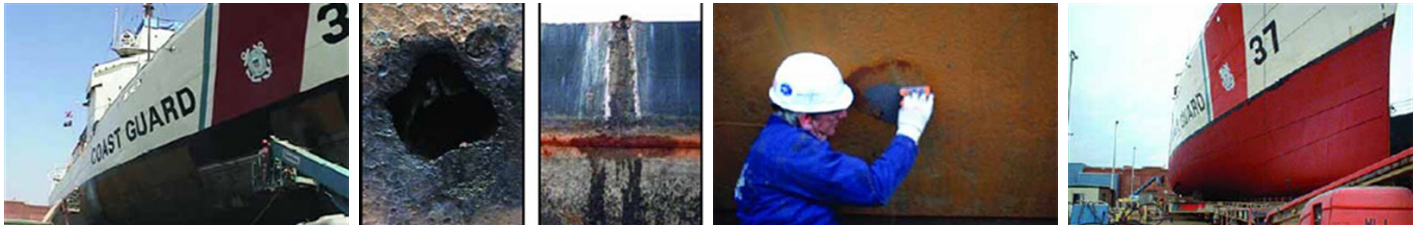
*Badly corroded hull at and below the waterline.*

- \* An overview of the USCG Taney ,
- \* Hull corrosion is clearly evident ,
- \* Belzona® 1111 is being finished ,
- \* The Taney has been repaired, and is ready to go back in the water ,

The Taney is the last remaining warship afloat that survived the attack on Pearl Harbor. She now serves as a floating museum in Baltimore Harbor. Belzona® 1111 was used to fill in badly corroded areas. Following this an 18" band around the entire ship was protected with Belzona® 5811.
