BELZONA SAVES SCHOOL DISTRICT OVER \$10,000

Industry: General Industry
Application: TCC-Tanks and Chemical Containment Areas

Customer Location: School System - Florida U.S.A.
Application Date: June 2002

Substrate: Fiberglass insulated duct board.
Products: * Belzona® 3111 (Flexible Membrane) ,
* Belzona® 3921 (GSC Conditioner) ,

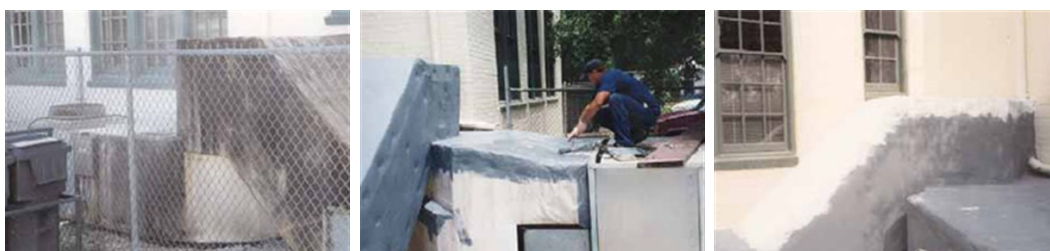
Photograph Descriptions

The insulated ductwork had a severe moisture problem. A product that would allow the moisture to dry as well as seal up the problem areas was needed.

- * The ductwork ,
- * Application in progress ,
- * The finished job ,

The products were brushed and rolled on in accordance with a modified version of Belzona Know-How Systems Leaflet TCC-4.

Belzona® 3111 (Flexible Membrane) allows the moisture inside the system to breathe without allowing rain water in. The products flexibility allowed for protection of the unusual design of the ductwork. The only alternative was to build a new system. Over \$10,000 was saved.
