# BELZONA 4000 SERIES FLOOR COATING FOR A STERILIZING ROOM

**Customer Location:** Medical Sanitizers - Minnesota U.S.A.  
**Application Date:** March 2002

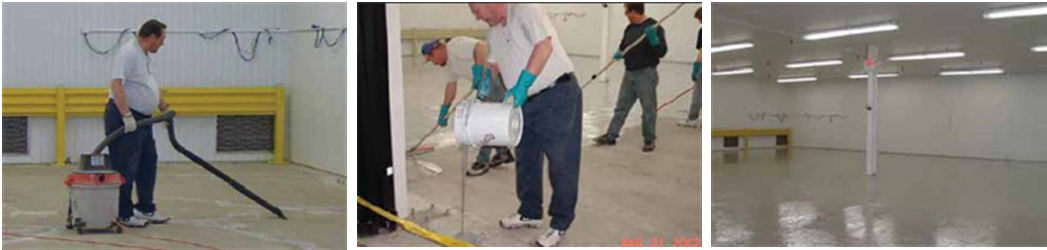
Floor was spalled, cracked and and therefore non-compliant with sanitary requirements.

- \* Final steps of surface preparation ,
- \* In progress ,
- \* Job complete ,

The application was carried out in accordance with a modified version of Belzona Know-How System Leaflet FPA-3. Shot-blasted floor, followed by thorough cleaning. Roller/brush application of product in a slurry-grade.
