BELZONA GRIP SYSTEM INCORPORATED IN FISHING VESSEL

ID: 4189

Industry: *Marine*
Application: *FPA-Floor Problem Areas*
Substrate: *Wood*
Products: ** Belzona® 4411 (Granogrip) ,*

Customer Location: *Fishing Trawler, Peterhead, Scotland*
Application Date: *1983*

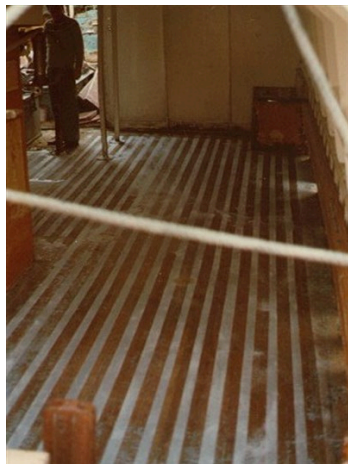
Wooden decking in the fish hold and on the working decks make for slippery hazardous conditions.

- * 1. Before the application. ,
- * 2. After the application. ,

The wooden deck is firstly routed and then the Belzona® 4411 (Granogrip) incorporating aggregate is applied into the rebate to maintain a flush surface yet create an aggressive grip system across the area.
