BELZONA WATERPROOFS NATURAL STONE FACADES

ID: 4204

Customer Location: Private Building, Amman, Jordan
Application Date: November 2012

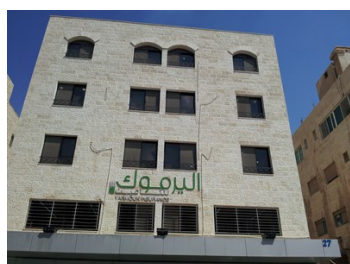
Water was penetrating the stones, creating damp areas on internal walls. The owner of the building needed to waterproof the structure and retain the natural appearance of the stones.

- * Front view of the building before application ,
- * Front view of the building after sand blasting ,
- * Applying Belzona 5122 with spray unit ,
- * Front view of the building after finish of application ,

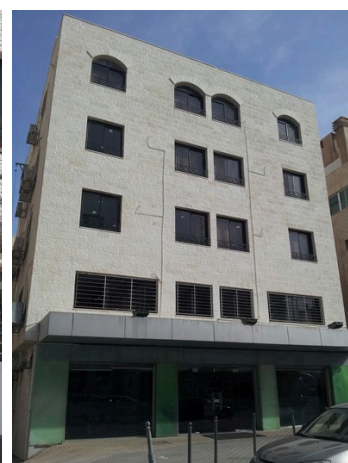
Belzona® 5122 Water Repellent Material protected the external structure from water penetration and gave the building new natural

appearance
