BELZONA MAKES MESSY JOB EASY CLEAN

ID: 4243

Industry: General Industry
Application: VPF-Valves, Pipes and Fittings
Substrate: Steel
Products: * Belzona® 1341 (Supermetalgilde) ,

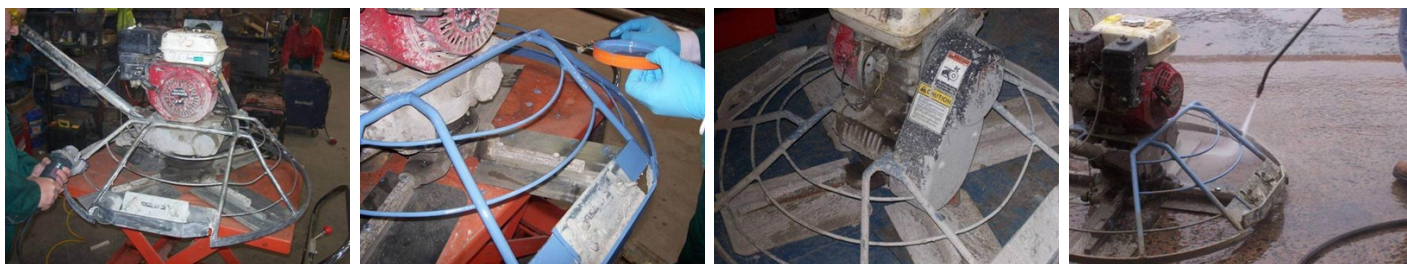
Photograph Descriptions

It takes someone about an hour with a power washer, hammers, and wire brushes to clean this before the next use. Frequent re-painting of the guard is required as the cleaning process also remove the paint.

- * Surface preparation ,
- * Brush Application of Belzona® 1341 ,
- * After application and first usage ,
- * Simple cleaning with power washer ,

During the use of the power floater the rotary guard gathers a lot of concrete that dries on.

Application carried out in accordance with Belzona Know-How System Leaflet VPF-2

The application of Belzona® 1341 has reduced cleaning time by 900-1200%. It now takes just 5 minutes and only requires a power washer!
