BELZONA PROTECTS NEW AMINE STRIPPER COLUMN

ID: 4266

Customer Location: Vessel fabricator, Turkey
Application Date: August 2012

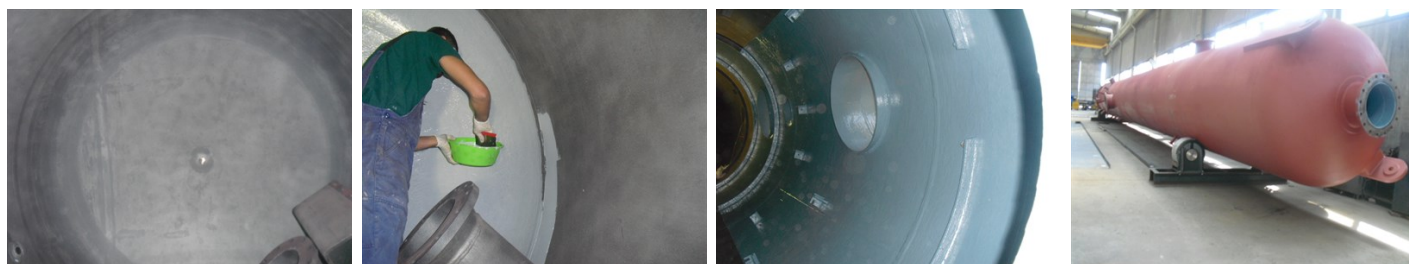
Photograph Descriptions

- * Vessel blasted ready for application ,
- * First coat of Belzona® 1391T applied ,
- * The finished application ,
- * The vessel completed. ,

Application was carried out in accordance with Belzona Know-How System leaflet TCC-5 and following a specific working specification prepared for the vessel.

If no coating was used then the vessel would have been suffering from corrosion within the first few weeks in service. Belzona 1391T provides corrosion protection in such a hot corrosive environment.
