BELZONA PROVIDES ALTERNATIVE SOLUTION TO BASALT LINING

ID: 4366

Customer Location: Steel Plant , Rourkela, India
Application Date: December 2012

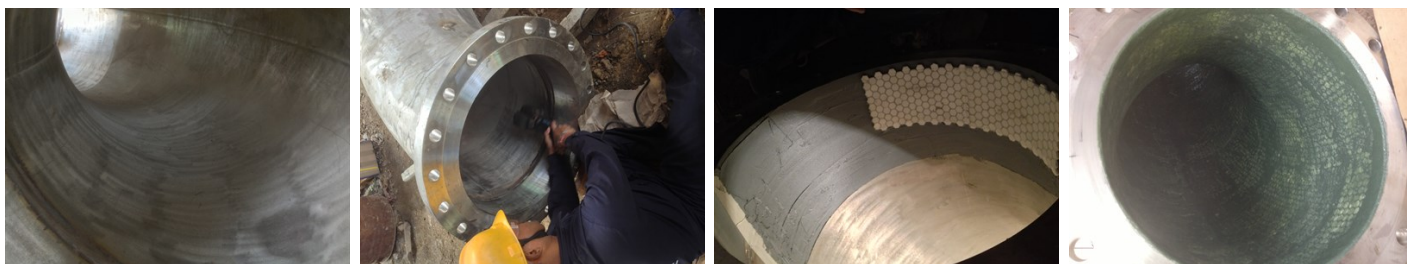
Photograph Descriptions

Basalt lining was not giving smooth surface as well as adding excessive weight to the Stainless steel elbow.

* Stainless Steel elbow Surface preparation by MBX Bristle Blaster Bonding Belzona® 9811 tiles Finished application with tiles grouted using Belzona® 1813 ,

Application was carried out in accordance with Belzona system Leaflet SHM-7. Belzona® 9811 alumina tiles were bonded to MBX Bristle Blaster prepared substrate using Belzona® 1161 and the grouted using Belzona® 1813.
