PROCESS VESSEL UPGRADE USING BELZONA ADHESIVE

ID: 459

Industry: Oil & Gas
Application: TCC-Tanks and Chemical Containment Areas
Substrate: Coated steel.
Products: * Belzona® 1111 (Super Metal) Belzona® 1391 (Ceramic HT Metal),
Customer Location: Offshore Oil Company - UK
Application Date: October 2003

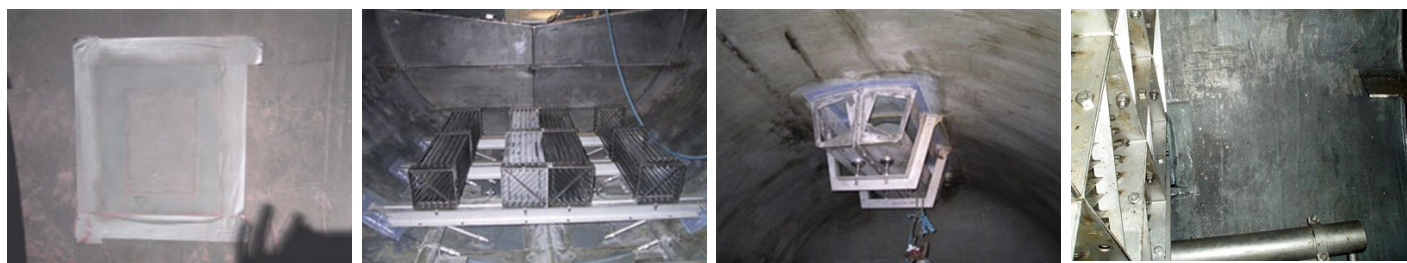
Photograph Descriptions

* Removal of existing coating to allow adhesive to bond directly to steel substrate. Bonding in of mounting clips and overcoating with Belzona® 1391. Sealing of gas demister using Belzona® 1111 and Belzona® 1391. View of application after 8 years in service ,

The original coating was removed in localised areas by blasting. The surrounding coating was cleaned and flash blasted. Once completed, mounting clips were bonded into position using Belzona® 1111. The clips were then coated using Belzona® 1391 which was overlapped onto the surrounding prepared coating in accordance with Belzona Know-How System Leaflet TCC-5.
